QEW and Highway 403 over Ford Drive Interchange Bridges

LEA were retained to carry out detailed inspection work and NDT testing at 14 fatigue critical bridge structures for MTO, Central Region. During the assignment, the work was extended to include inspection of 4 steel box girder bridges at the QEW and Highway 403 over Ford Drive Interchange.

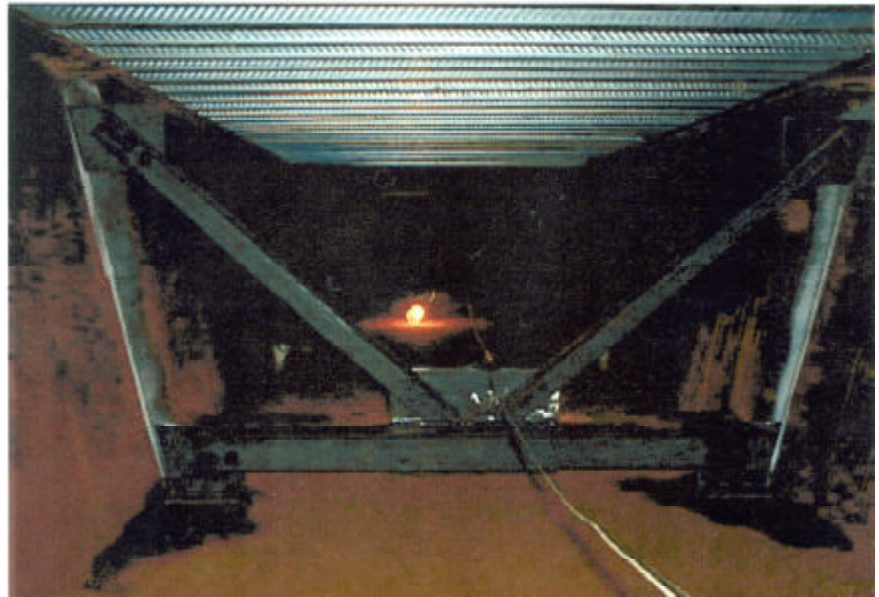
View of new K-Bracing inside box girder, connection also added for stiffener to bottom flange.

- ◆ Shift internal X-bracing frames away from damaged web areas by one stiffener location. This provided access to the webs for repairs and eliminated further out-of-place forces to damaged areas. The detail at the new internal bracing location included connection of the stiffener to the bottom flange and installation of new K-bracing.

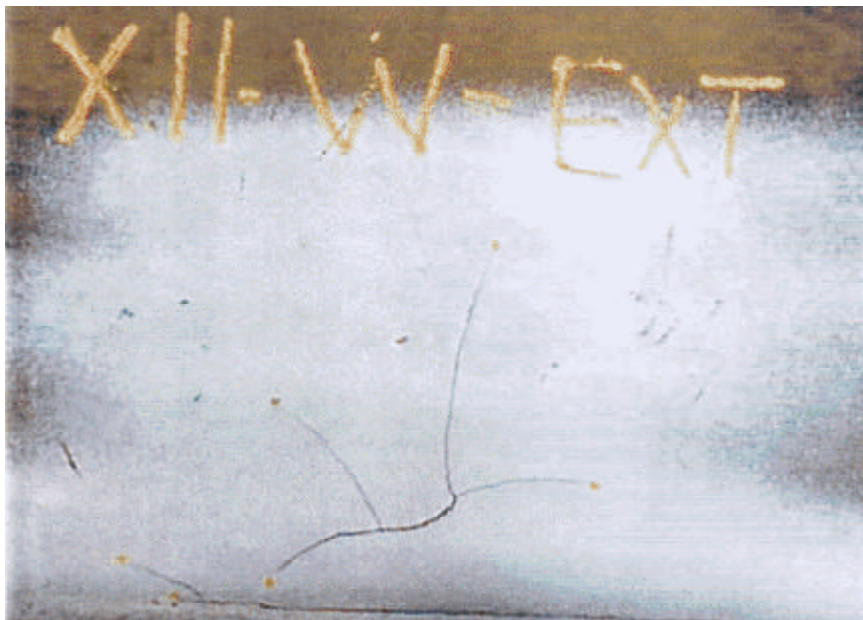
Cracks had been noted at some box girder webs during routine OSIM inspections. LEA found that distortion-induced cracking had occurred in girder webs at 119 out of 120 locations where internal X-bracing angles connected to web stiffeners near the bottom flange. Stiffeners had not been connected to the bottom flange, and forces in these angles were transmitted to the web plate causing out-of-place bending. These bridges are subject to heavy truck traffic volumes, but were only 20 years old at the time. The cracking in the webs varied in severity, but at some locations had progressed 450 mm up the web vertically and 400 mm horizontally above the bottom flange.

Typical distortion induced cracking at box girder web viewed from outside.

- ◆ NDT testing was again carried out to define the ends of cracks;
- ◆ Cracks in the webs were drilled at the ends to arrest further growth.
- ◆ Following a pre-determined sequence, the lower parts of stiffeners at damaged web areas were cut, and the area ground smooth. Abrasive blast cleaning was carried out and

non-slip splice plates installed utilizing high strength bolts. The connection of the web to bottom flange was restored and the web stiffener rebuilt.

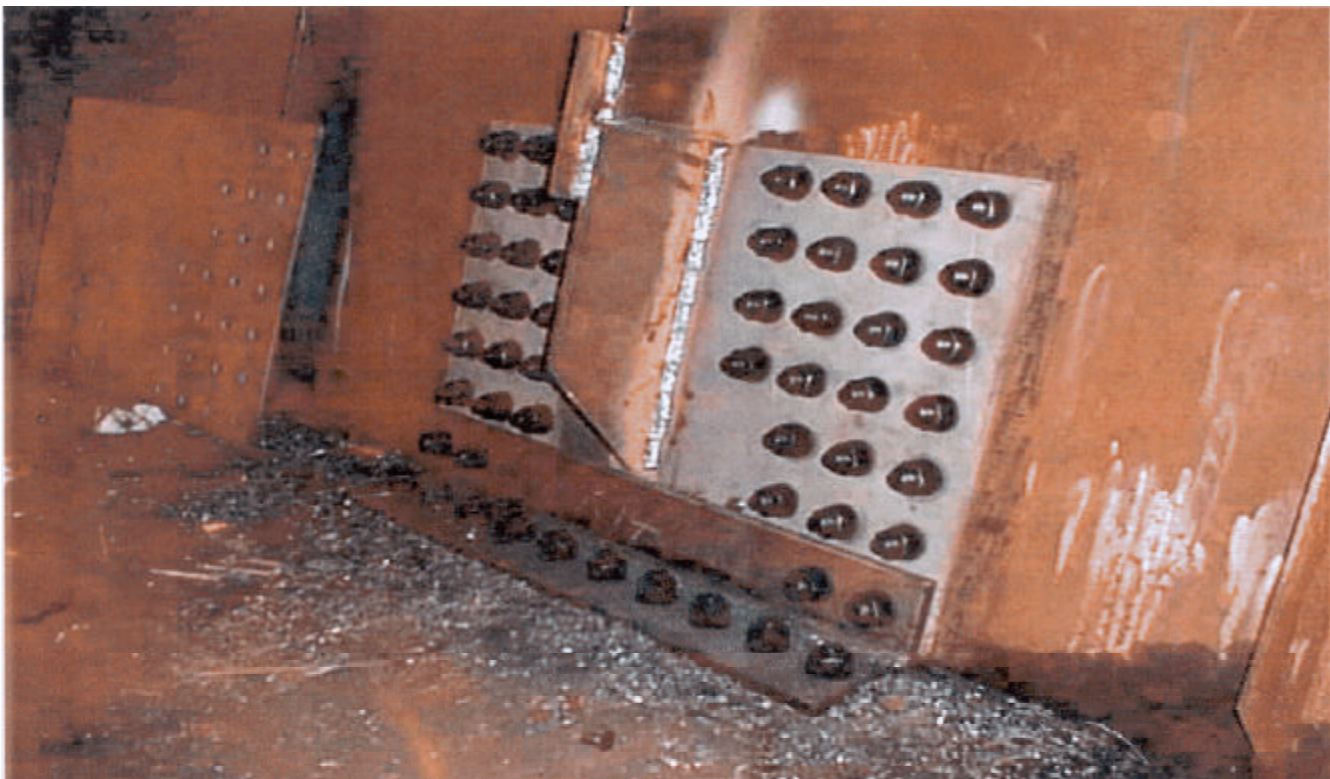
Typical web repair plate assembly inside box-girder, note also stiffener restoration and bottom flange connection.
