## **QEW-Highway 403 at Ford Drive Bridge Repairs**

Peter Ojala, P.Eng, Head of Bridges and Structures, Lea Consulting Ltd.

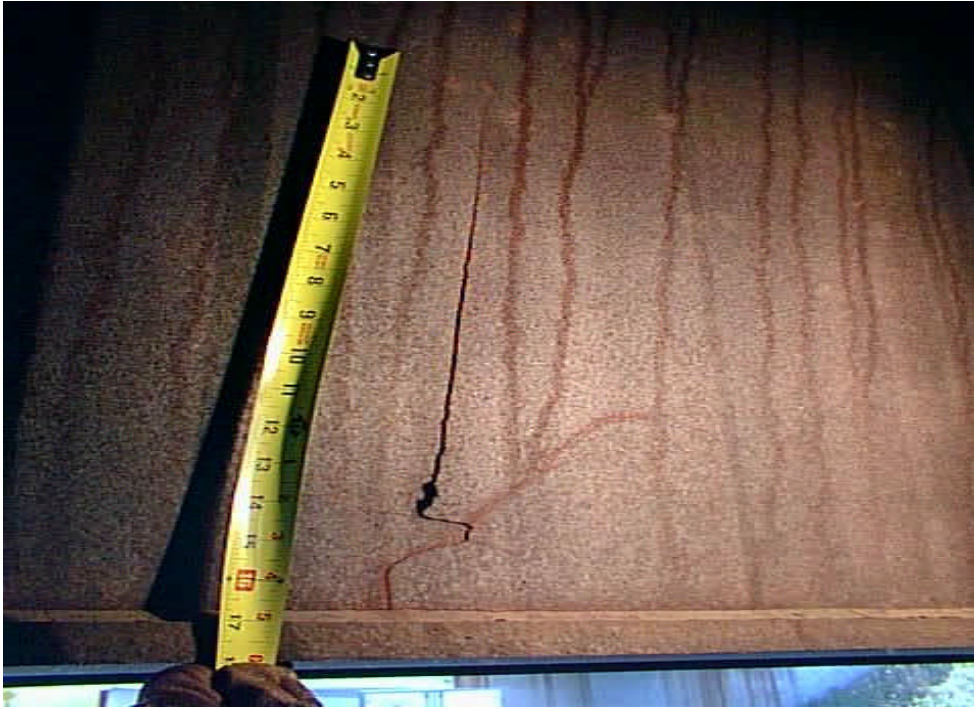
Photo: Cracks at one box girder web. Web to bottom flange connection was also cracked completely through

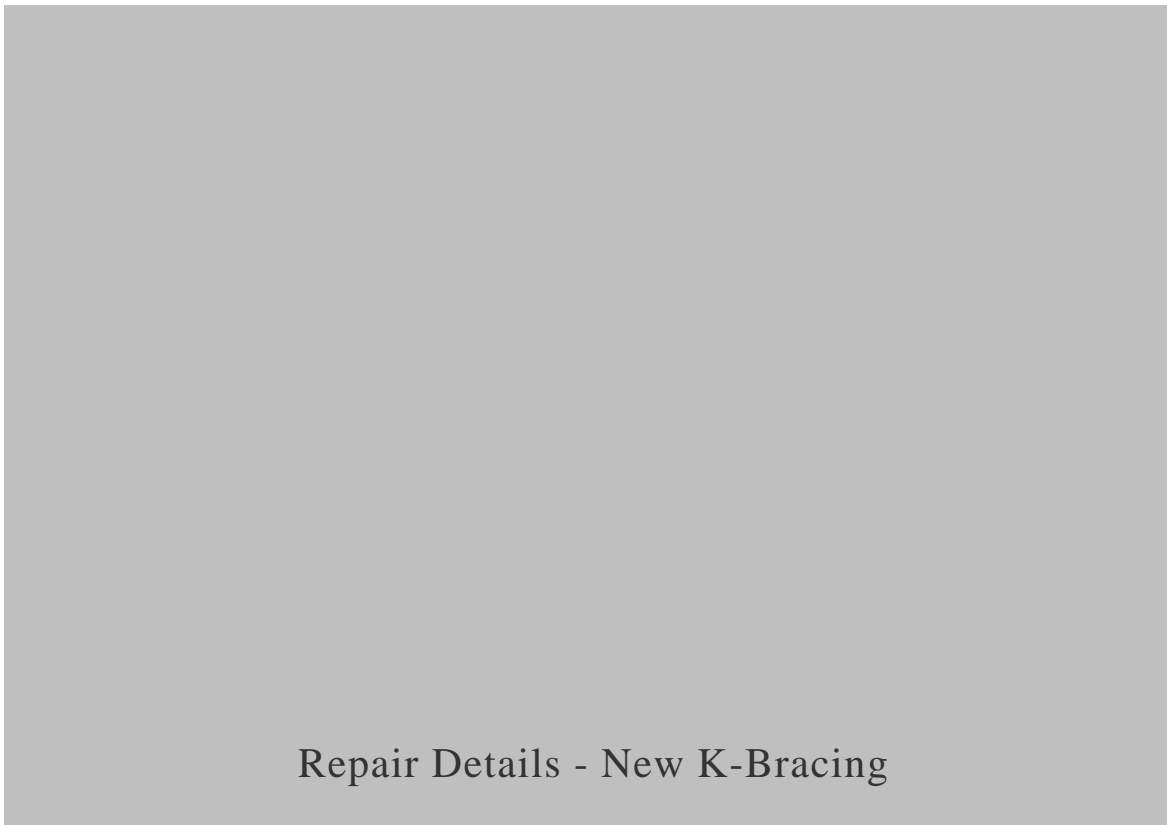
Photo: Typical new K-frame details

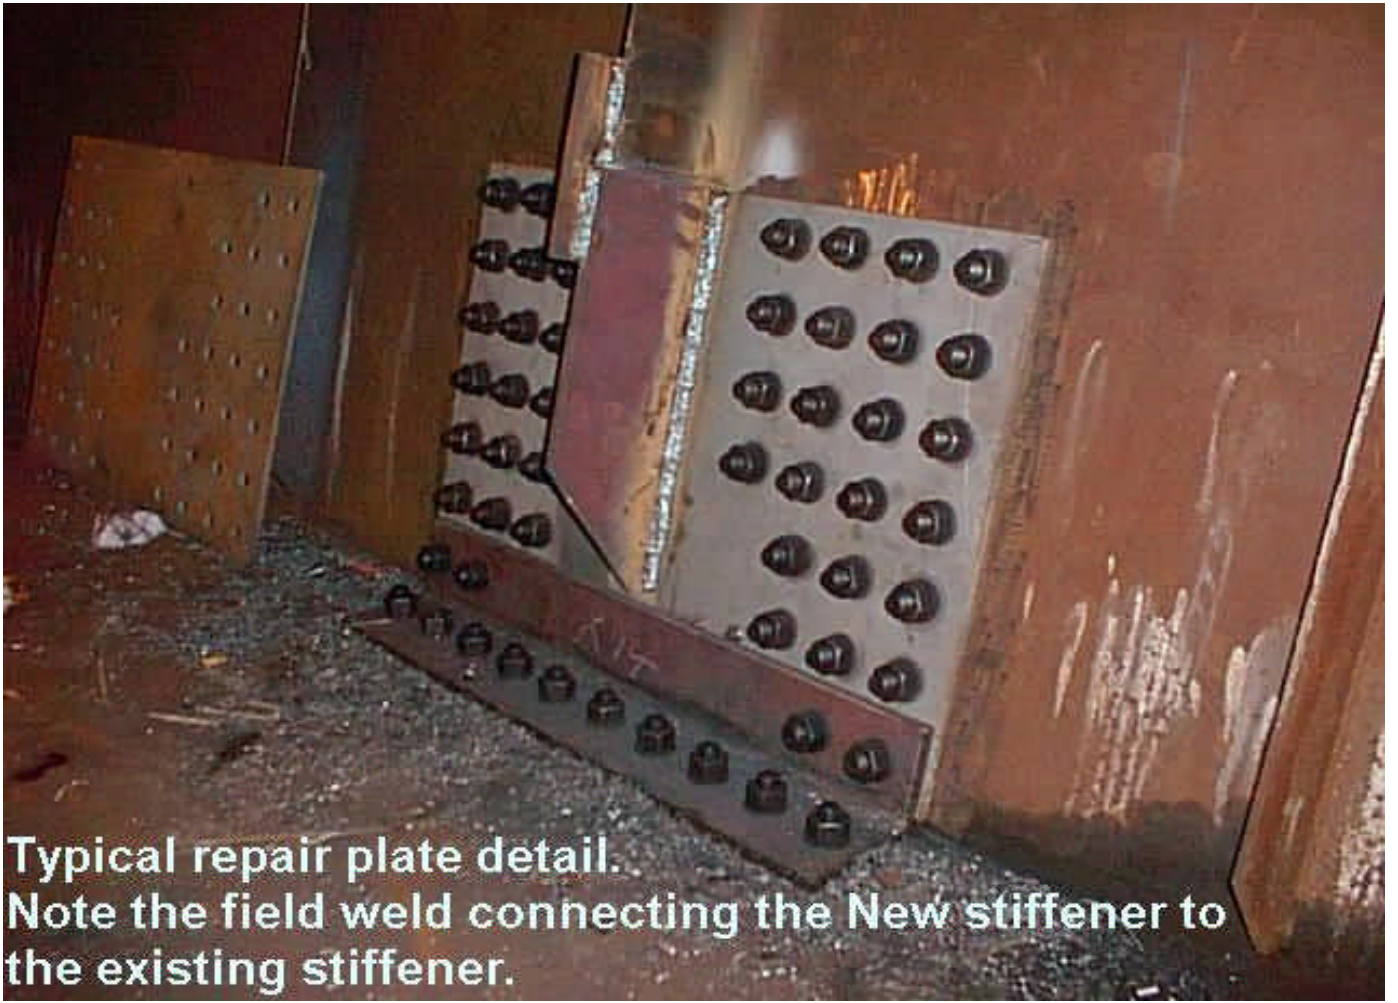
**Typical repair plate detail.  
Note the field weld connecting the New stiffener to  
the existing stiffener.**
